# CHURCH OF ALL SAINTS, GRAFHAM, CAMBRIDGESHIRE:

## SOUTH AISLE & NAVE RE-ROOFING (& ASSOCIATED STRUCTURAL REPAIRS)

Iain Frearson, Freeland Rees Roberts Architects

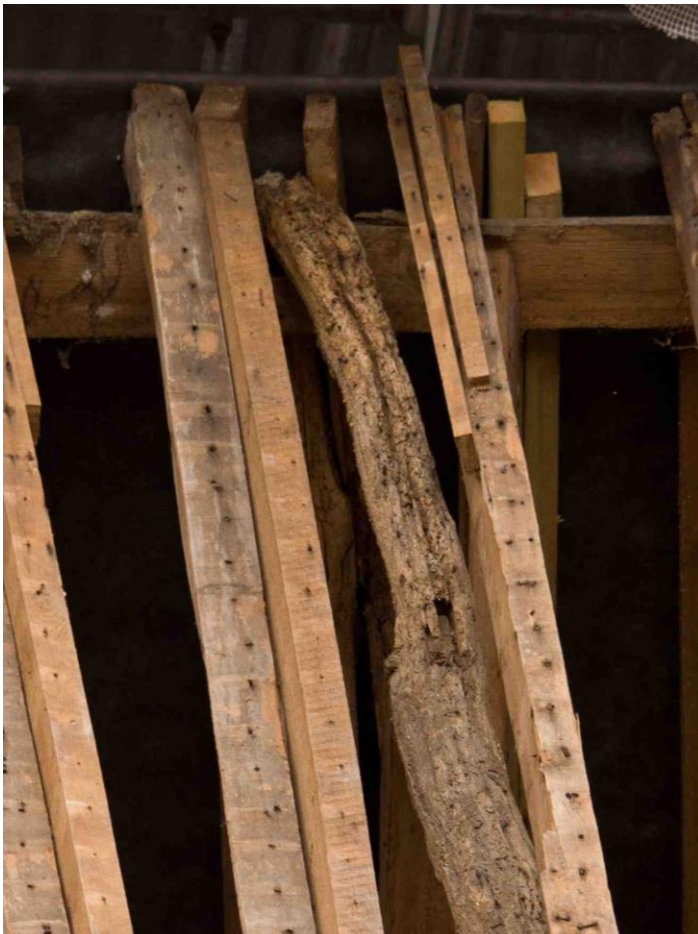
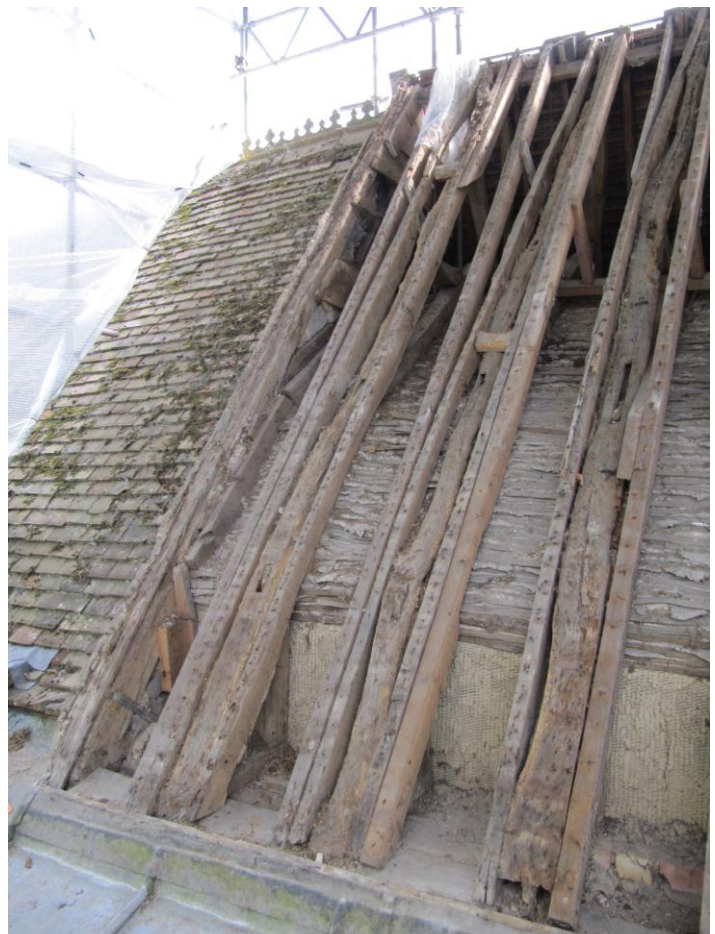
[Church of All Saints' Grafham. Nave Roof (North Slope). Note all **previous** partnering timbers]

The condition of this roof slope was very poor indeed:

- i) Failing Roof Covering
  - a. Rainwater ingress
  - b. Failing nail fixings to battens failing, resulting in slippage of battens and risk of cascading of roof tiling – the roof tiling was considered ‘live’

- c. Failing tiles generally. Including to ridge (shaling, damaged, missing tiles)
  - d. Inability to carry out tiling repairs/maintenance due to poor condition of the roof covering (ie. risk of causing more damage than was able to be repaired)

- e. Tiling at low level was cemented in position, making tiling repairs problematic
  - f. High levels of moss on roof helping increase moisture levels in tiling and below in/around the roof battens, roof structure, ceiling structure, etc.

- ii) Inadequate ventilation of roof space (torching at all levels prevents ventilation through tiles, and eaves are unventilated, etc.)
- iii) Evidence of decay to timber roof structure:

- a. Visibly decayed timber (some historic, some apparently not);
  - b. Soft / ‘dopey’ timber to rafter ends and wall plate;
  - c. Wall plate slightly damp to touch;

Re-roofing (and associated repairs) with improved ventilation

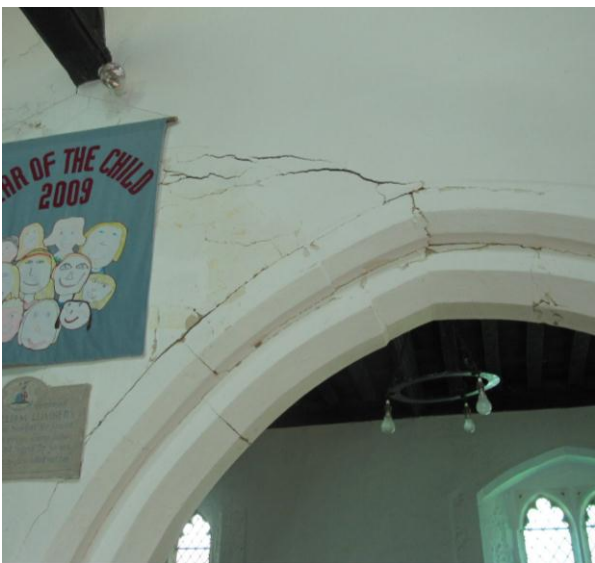
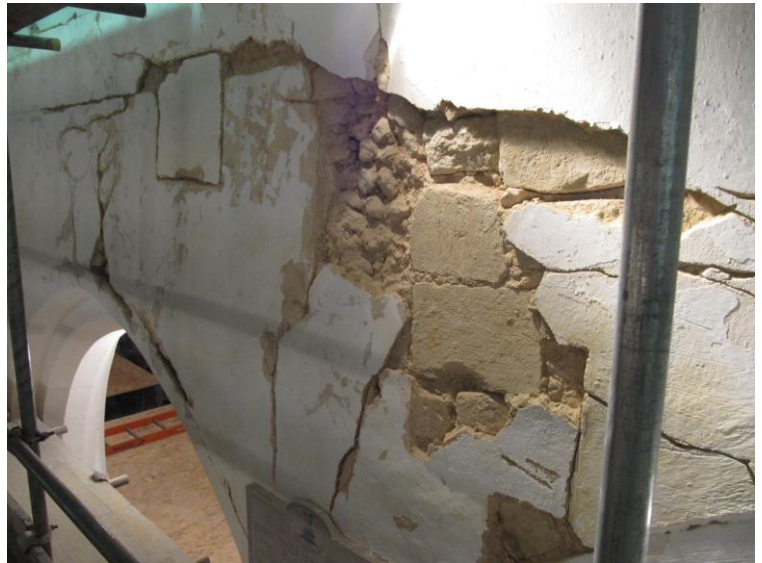
[Church of All Saints' Grafham. Nave (North Wall). Note structural movement]

Structural Engineer Ed Morton of the Morton Partnership has advised that, “...*The church has been affected by some subsidence, principally around the eastern pier forming the junction between the nave, chancel, and north aisle. This is a relatively weak section of masonry due to the loss of core where the rood stair rises within the core which reduces the piers ability to support the thrust from the arches of the north arcading and chancel arch. Therefore as the springing point of the arch is allowed to move slightly this then induces movement to occur within the arches themselves. As well as the movement to this pier it seems likely that at least the eastern column of the arcading has subsided...*”

- i) Pinning the large pier of masonry at junction between the Chancel, North Aisle, and Nave, to allow it to act monolithically;
- ii) Reinforcement of the thin wall to the east of the roof stair and associated buttress (east wall of the North Aisle) to provide it with greater strength to help resist movement);
- iii) Continuation of tree management;
- iv) Continuation of monitoring.

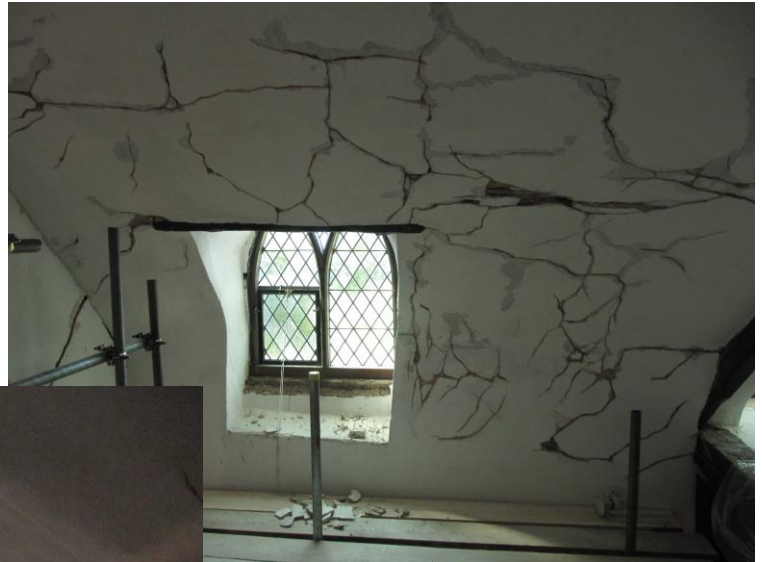
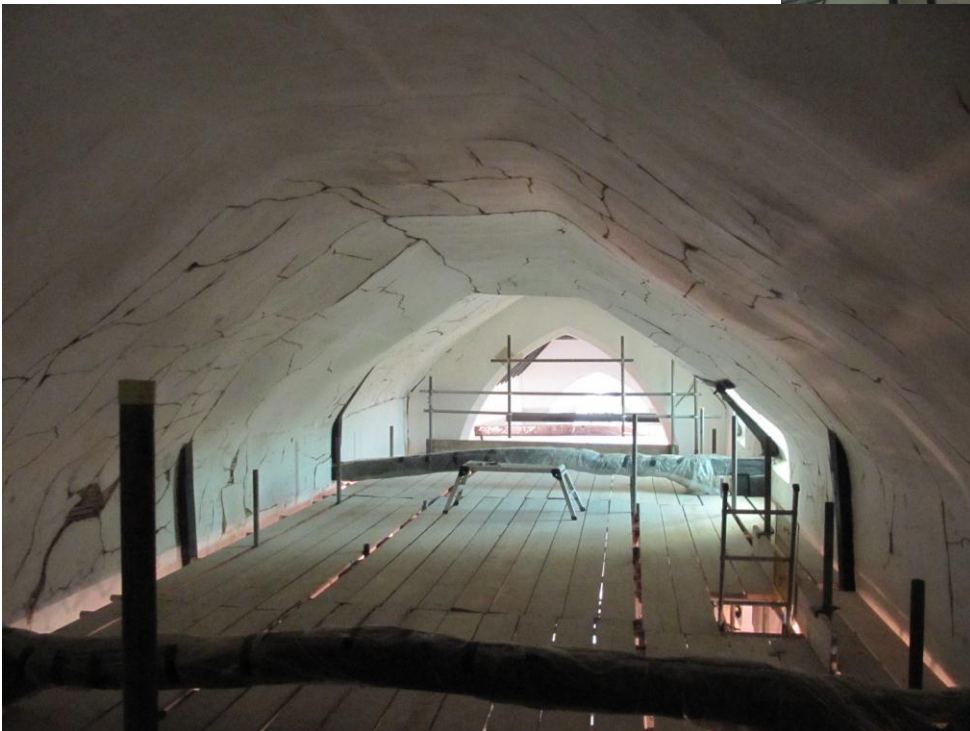
[Church of All Saints Grafham. Nave Ceiling, with views looking east and south]

Internal redecoration (incl. plaster repairs)

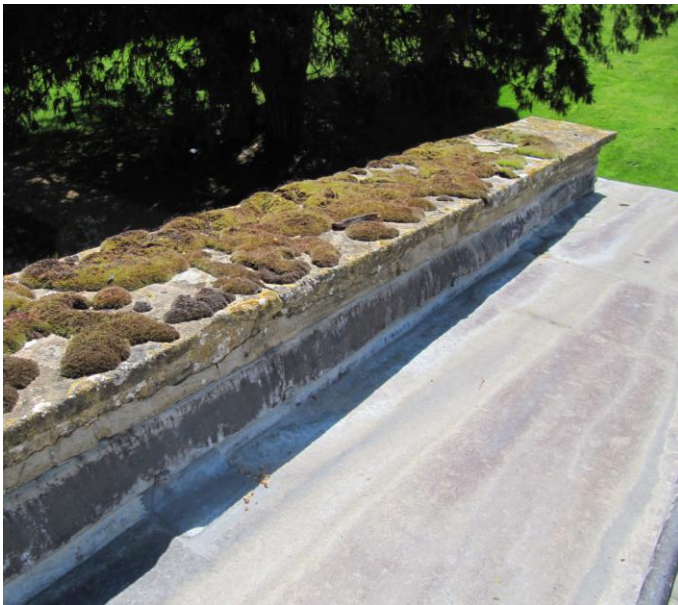
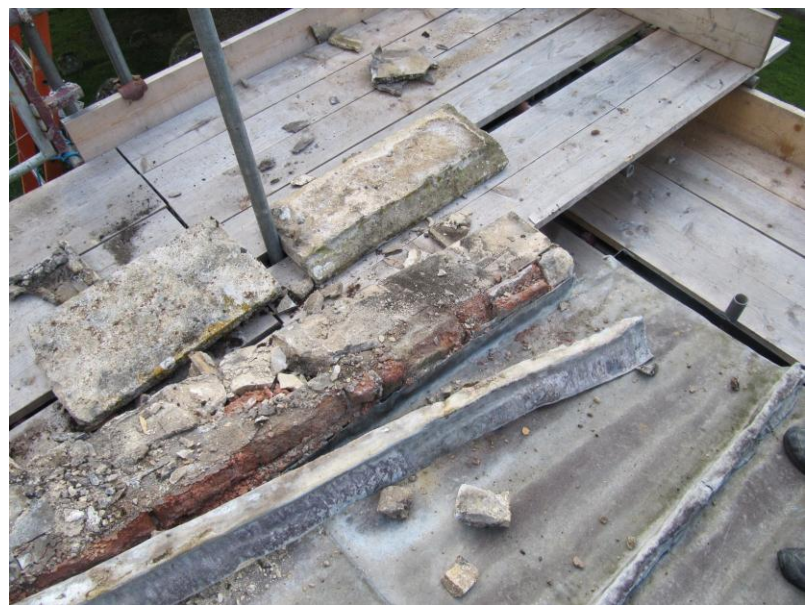
- i) Failing roof covering
  - a. Lead roof sheeting in very poor condition (beyond end of working life);
  - b. Extensive splits and fractures to lead sheet (especially to rolls);
  - c. Lead sheet was sagging in places (due to drops in timber boarding below);
  - d. Lead had been extensively patched & repaired but was leaking again.
  - e. Lead abutment flashings oversized and failing (now repaired)
- ii) Possible timber decay to roof boarding/structure
- iii) Failing east parapet wall
  - a. Failing copings (split/fracture stones, open joints)
  - b. Failing flashings (splits to lead, failing pointing):
- iv) Eaves Rainwater Gutter needed re-setting and replacement.

[Church of All Saints' Grafham. South Aisle Roof (East End) Location of parapet wall repairs.]

Repairs to lead roof

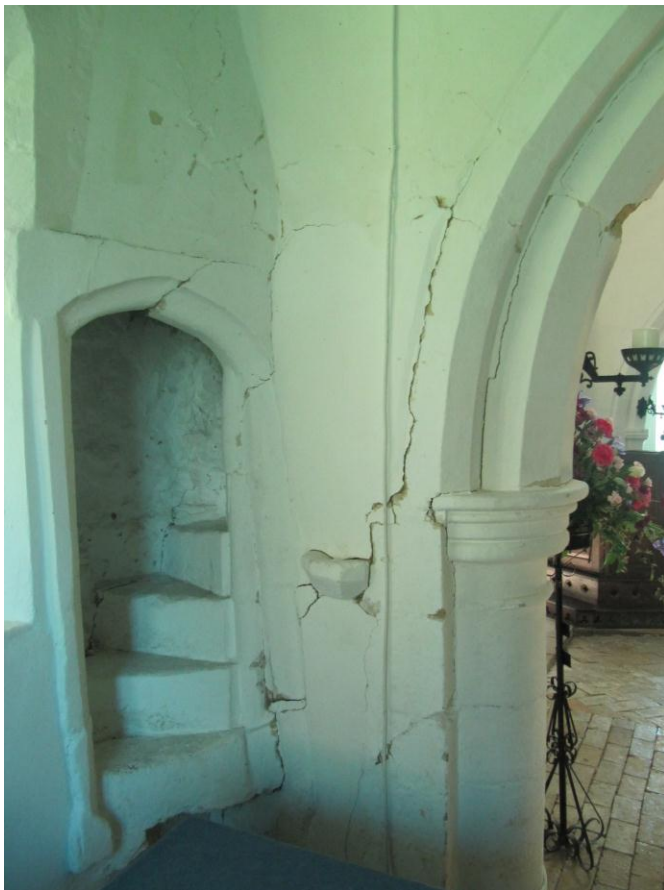
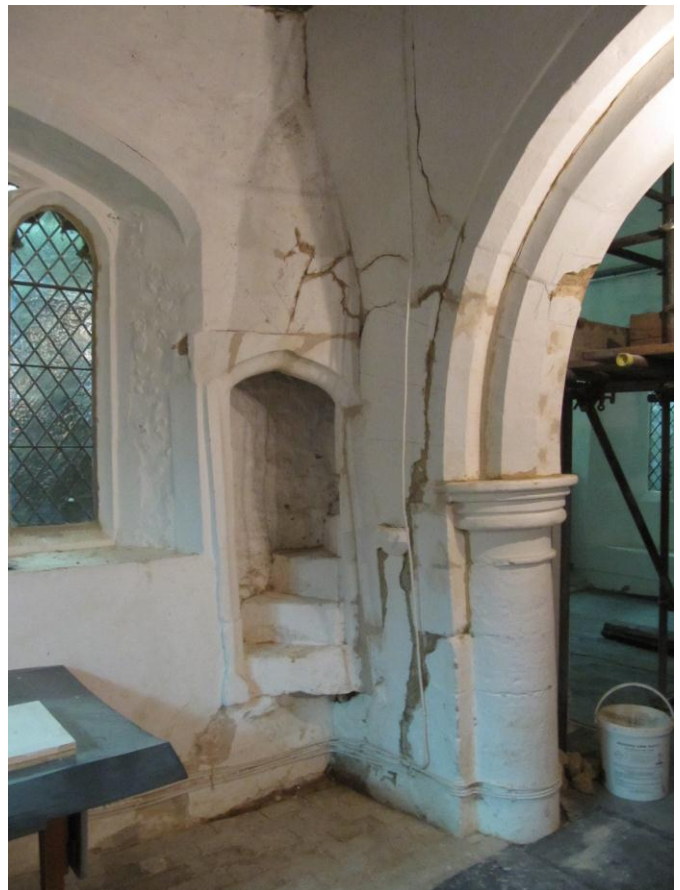
[Church of All Saints' Grafham. North Aisle (East End) Structural work pre- and during repairs]

Structural repairs at east end of North Aisle (around the Roof Stair)
